**ಕರ್ನಾಟಕ ವಿಧಾನ ಪರಿಷತ್ತು**

**TECHNICAL REPORT TOWARDS THE FIRE ACCIDENT  
OCCURRED ON 11.08.2023 IN QUALITY ASSURANCE  
LABORATORY INSIDE THE PREMISES OF BBMP HEAD OFFICE**

Ret. Hon'ble Chief Commissioner, BBMP office order No BBMP/CC/PR  
118/2023-24, dated:11.08.2023

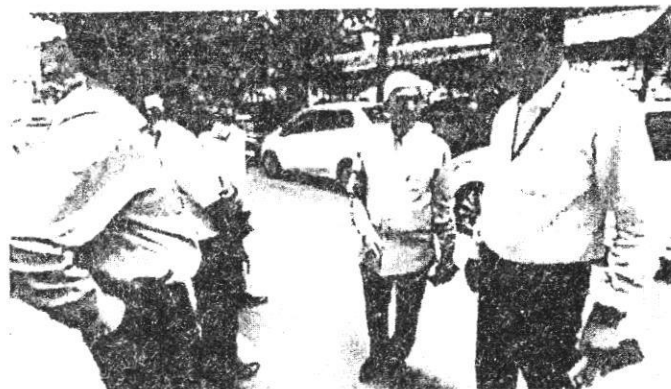
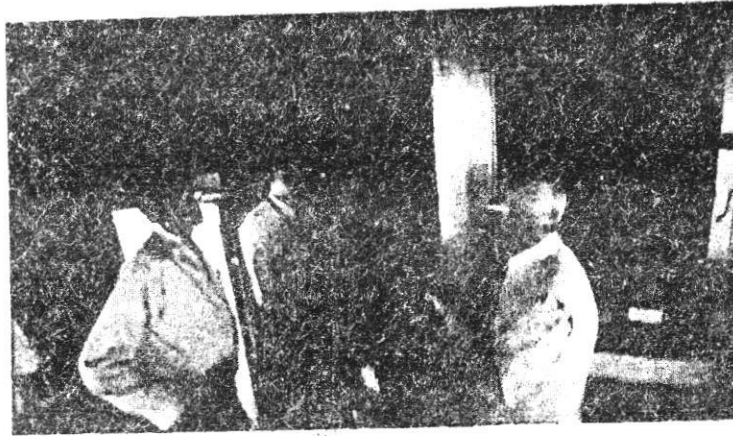
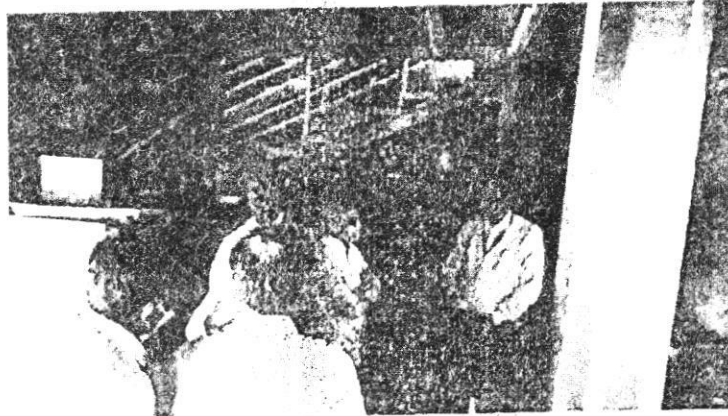
The photographs showing the visit made by the Principal is as below:

The Experts jointly opined that, the laboratory is housed in a very small space and is not adequate as per standard specifications. They informed that, there should be circular space around each equipments for each person working on the equipments during conducting the tests. In the present instance they opined that, the equipments in the laboratory are cramped and there is not even lateral space between the two equipments for a person to handle the equipments properly.

The experts also opined that, the mezzanine floor constructed out of steel fabrication over the laboratory is an ill-conceived idea. It was also opined that, the height of the laboratory roof should have a minimum height of 3.75m to 4.0m (12ft to 14ft) with cross entries and ventilation

The experts opined that, small windows have blocked the free passage of smoke that has erupted due to fire. They concluded that, the laboratory should be immediately disused.

1. The laboratory situated in the BBMP head office premises, may be disused and new laboratory block may be constructed within the head office premises in the space available in front of "Naukara Bhavana".
2. The ground floor and the mezzanine floor may be used as "Office Space". The windows which are 1.2m x 1.2m of size may be altered to minimum 1.8m x 1.2m.
3. The equipments in the laboratory are in very good condition and laboratory block should be constructed so as to re-install the available equipments without any damage.
